Demolition Observations/Findings of the City of Houghton's "Big Deck"

U.P. Engineers & Architects, Inc.

September 21, 2023

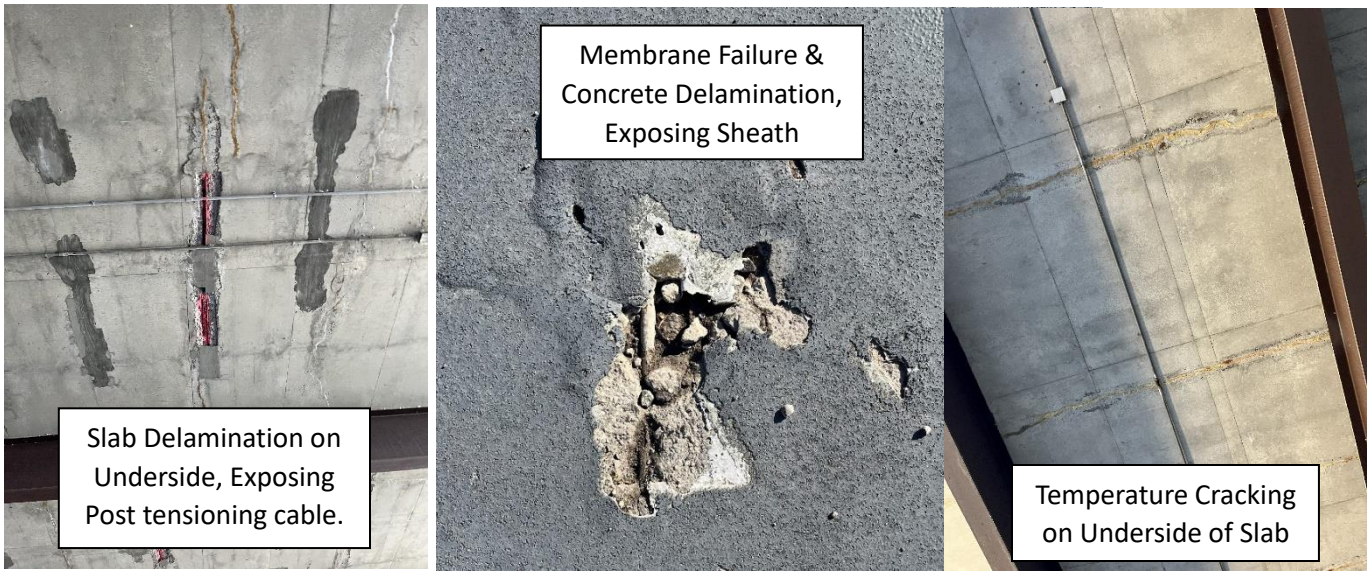
Slab Delamination on Underside, Exposing Post tensioning cable.

Membrane Failure & Concrete Delamination, Exposing Sheath

Temperature Cracking on Underside of Slab

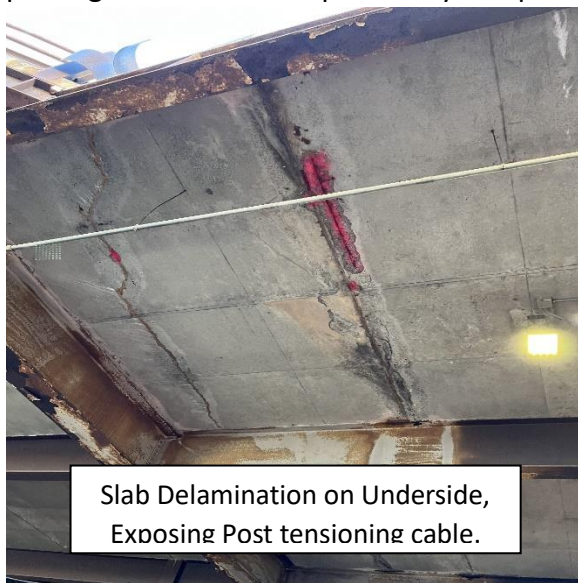
Slab Delamination on Underside, Exposing Post tensioning cable.

hard or far at the underside of the parking decks concrete slab or the concrete deck to locate them. On several occasions throughout the demolition and even during the demolition preparation, there were substantial sections of concrete that had fallen from the underside of the structures slab in areas that no work was even being conducted in. When mentioning this to several City staff members after the fact, it was noted that they had occasionally needed to remove sections of concrete that had fallen from the underside of the slab from Lakeshore Drive in the past and that they routinely inspected the underside of the concrete with a lift and a pike

pole to identify and remove loose concrete. While that may not be of concern to some, this is certainly a major safety hazard when you consider that the concrete is falling approximately 15 feet to the ground with enough force to seriously injure or even kill someone depending on the size of the falling debris.

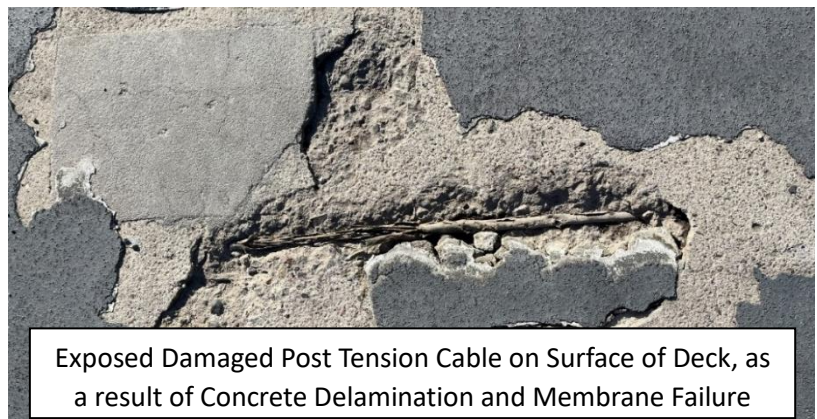
Exposed Damaged Post Tension Cable on Surface of Deck, as a result of Concrete Delamination and Membrane Failure

deck where cracks were evenly spaced out parallel to the spans which is a direct result of inadequate compressive forces from the post tensioning strands. However, this was confirmed throughout the demolition of the parking structure as many of the strands/cables had little to no tension left in them, it is estimated that approximately 50% of the strands were compromised completely or partially, as there was very little or no tension to release when cutting the strands.

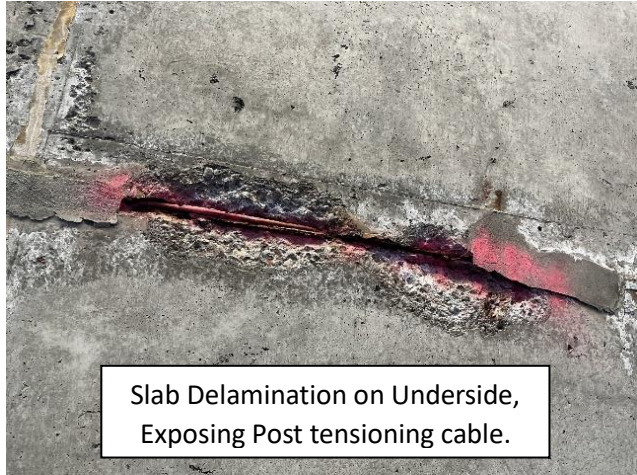
Slab Delamination on Underside, Exposing Post tensioning cable.

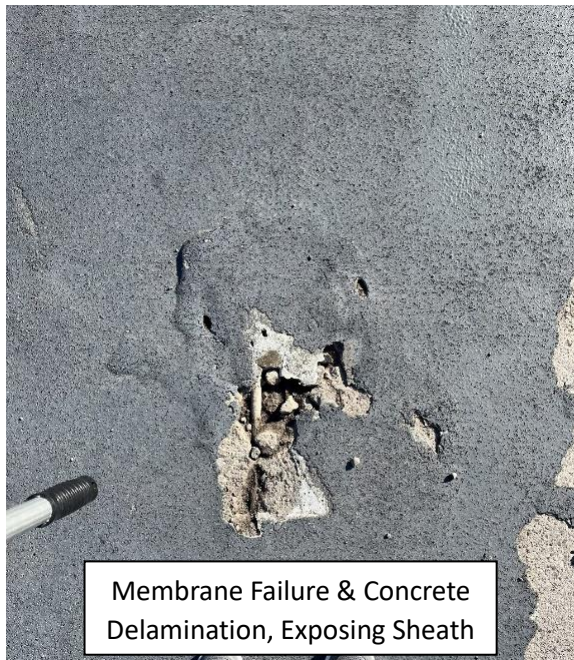
Membrane Failure & Concrete Delamination, Exposing Sheath

infiltrated the concrete up to 3 inches, the original post tensioned slab was only 5 inches thick in most areas, other areas being 7 inches thick. Despite the City of Houghton's efforts over the years to limit chloride and moisture infiltration to the concrete, the chlorides and moisture that had already penetrated the slab continued to diffuse through the slab to the reinforcing steel in the post tensioned slab and compromise the concrete through the repeated freeze-thaw cycles. The membrane installed in 2013 has since been compromised and is missing or deteriorated in various locations throughout the surface of the elevated slab allowing chlorine laden water to soak through the concrete slab further compromising reinforcing steel, deteriorating the

concrete and compromising post tensioning cables/strands and the sheaths protecting them. Even after the elastomeric membrane was installed concrete underneath the membrane was continuously spalling each winter further degrading the slab and the membrane could only be repaired during summer months due to temperature application limitations.

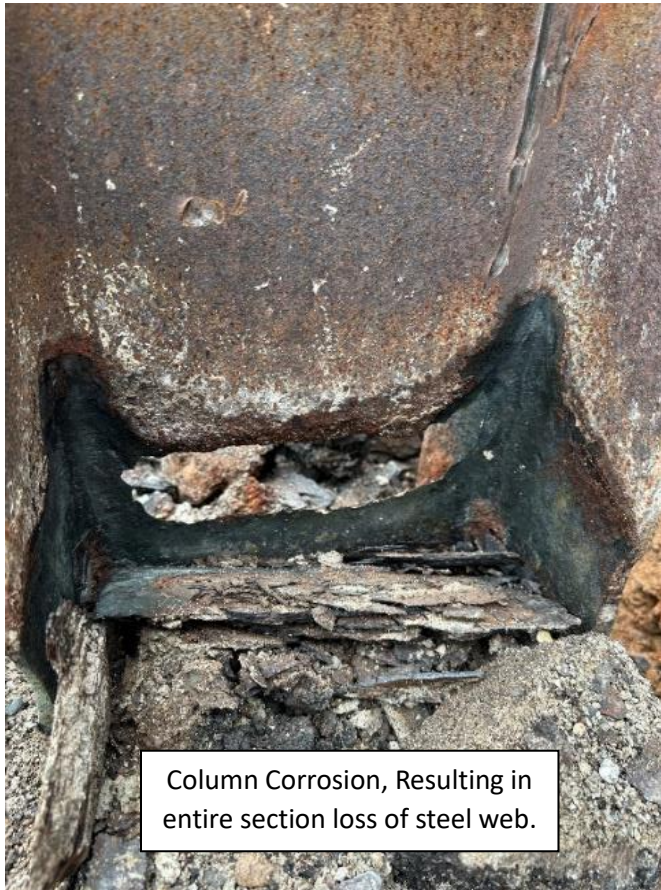
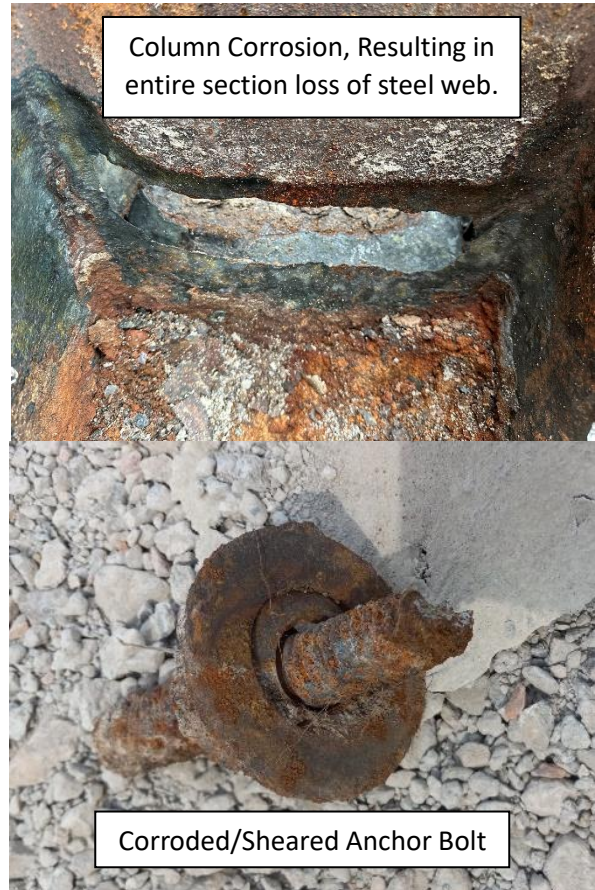
One of the larger more concerning observations made during the demolition of the Big Deck was the condition of some of the connection plates between the concrete footings and the vertical steel columns supporting the deck and the subsurface condition of the H-Piles/columns, which were completely corroded including the anchor bolts in some instances. The column pictured below had completely rusted through and was located approximately six inches below grade. These connections and structural members were not previously thoroughly evaluated as it would have required destructive investigations but has been noted that columns were corroded at grade in several previous evaluations. In the most recent evaluation for the parking deck completed by Pierce Engineers in 2020 it was mentioned that there were bracing beams spanning north/south under the Eastern half of the deck that had minor buckling from twisting out of plane, and the failed subsurface connection plates and section loss of columns are likely the result of this due or at a minimum a contributing factor to the loss in horizontal movement resistance.

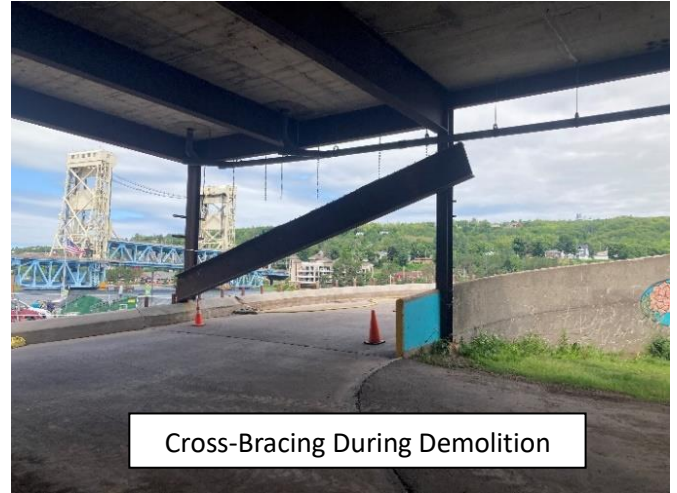
Throughout demolition shoring and bracing was required to prevent excessive lateral movement or swaying when processing the concrete deck, while this can be attributed to several factors, it was primarily only an issue in areas that were found to have corroded or compromised connections/anchor points as described and pictured previously. In order to safely take down the structure large beams were welded as cross bracing to stabilize the frame, as shown to the right.

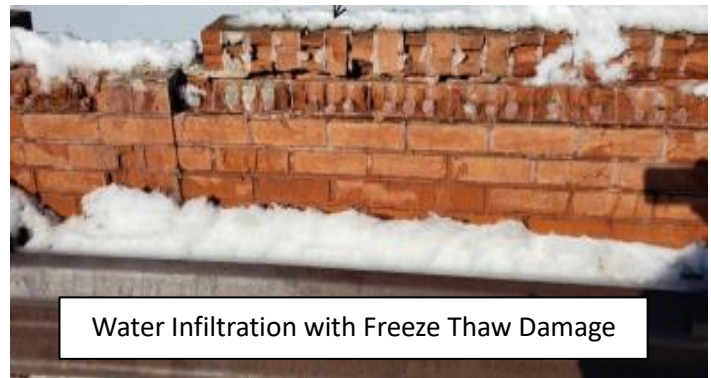
The parapet wall/masonry wall bordering the North Side of the eastern half of the deck had severe freeze thaw damage from extensive water infiltration over the years. Sections of this wall were to the point that one could remove bricks by hand, this area was closed for several years leading up to the demolition for that reason.

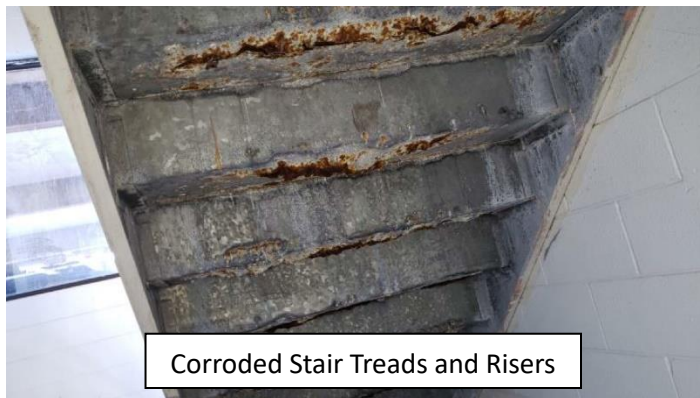
The eastern stair tower had extensive corrosion of the stair pan risers and treads as well as multiple failed welds, leading to the closure of the eastern stair tower several years ago. Even

with the closure of the stair tower and minimal use, on several occasions there were sections of the stair pan that had fallen due to the extensive corrosion. In addition to the above three of four exterior walls were compromised due to freeze/thaw damage essentially meaning the stairwell needed to either be torn down or completely rebuilt.
